Crash of Skydive Quantum Leap  
de Havilland DHC-6-100, N203E  
Sullivan, Missouri  
July 29, 2006

AIRCRAFT ACCIDENT SUMMARY REPORT

NTSB/AAR-08/03/SUM  
PB2008-910403

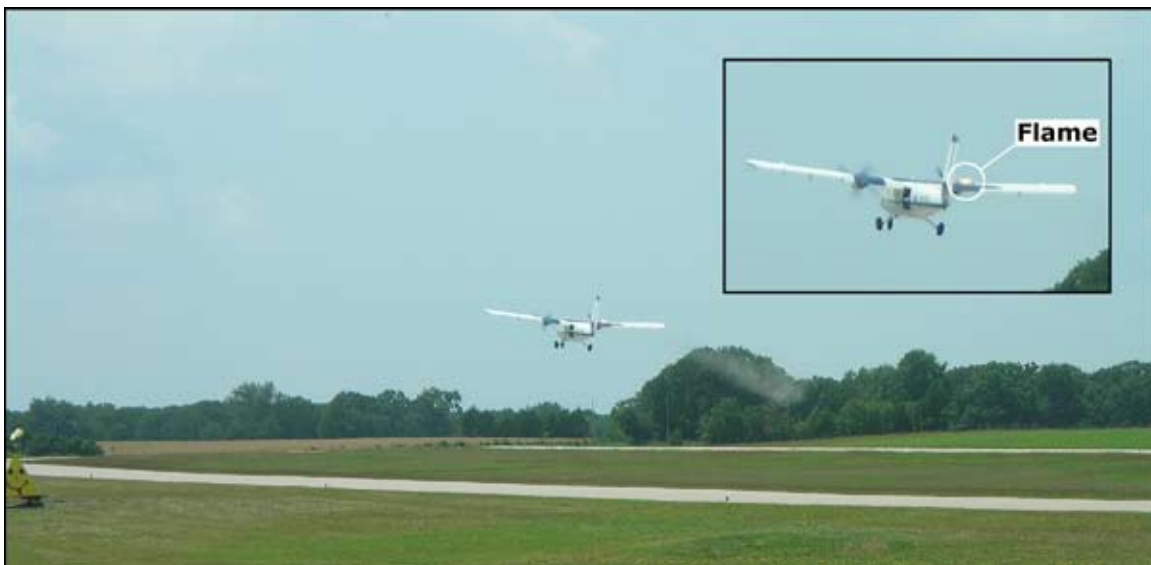
According to photographic evidence provided by a witness, the pilot taxied the airplane onto runway 24 from the intersecting taxiway, which is about 1,700 feet from the runway's west end, and began a takeoff roll to the west from that location, rather than using the runway's entire 4,500-foot length. Photographic evidence depicting the airport windsock shows that the airplane departed into a moderate headwind. Witnesses at the airport reported seeing the airplane take off and climb to about treetop height.<sup>2</sup> Several witnesses reported hearing a "poof" or "bang" noise and seeing flames and smoke coming from the right engine. One witness reported that, after the noise and the emergence of flames, the right propeller was "just barely turning." Photographic evidence shows that, at one point after the flames occurred, the airplane was about one wingspan (about 65 feet) above the runway. (See figure 1.) One witness estimated that the airplane climbed to about 150 feet.

**Figure 1.** Witness' photograph showing accident airplane above the end of runway 24 with smoke and flames visible from right engine. (Inset shows an enlarged view.)

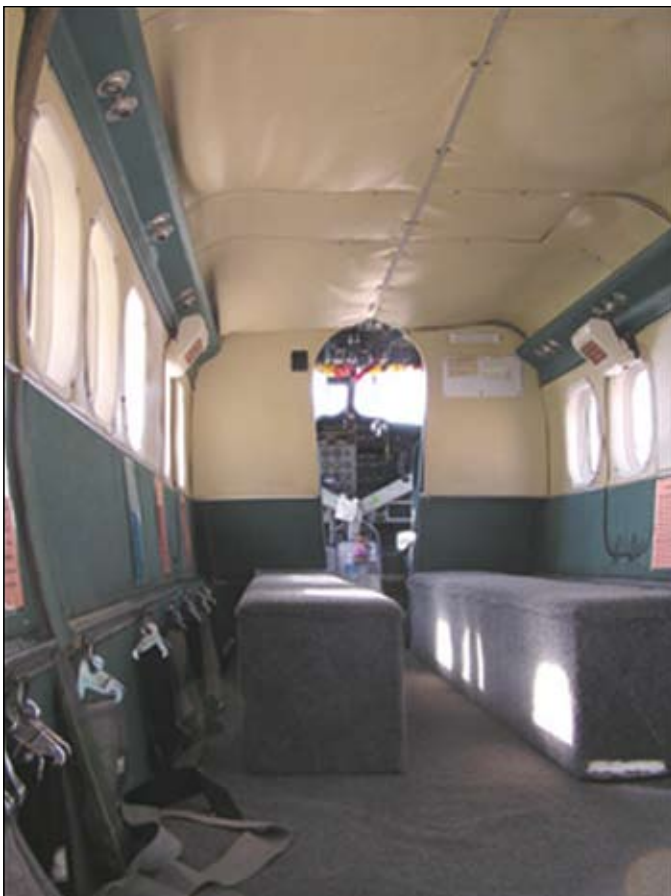
**Figure 3.** Pre-accident photograph of accident airplane interior showing both foam block benches and some left-side restraints (view from left-side cargo door, looking forward); photograph provided by a relative of the pilot.

wreckage; instead, two solid foam blocks, each measuring about 5 to 6 feet long and 15 to 18 inches tall and wide, were in the airplane. Each solid foam block served as a seating bench that extended aft from the forward cabin, parallel to each exterior cabin wall. The position of the two foam block benches allowed space for a center aisle and space between each bench and sidewall. (See figure 3 above.)

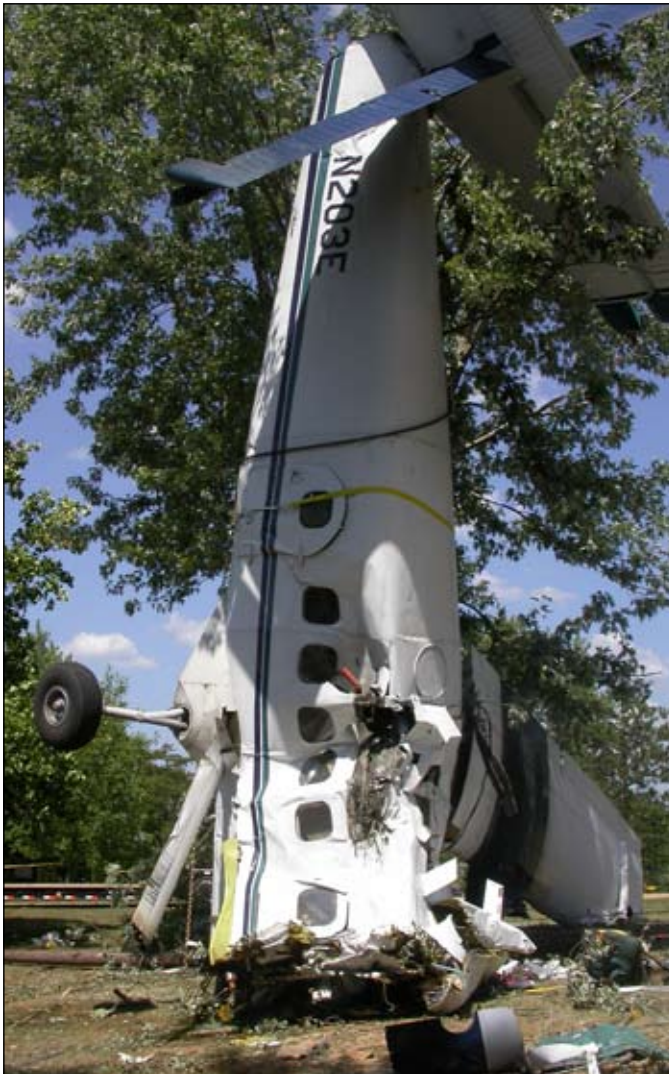
**Figure 4.** Photograph of the crush damage on the fuselage (right wing removed from wreckage).

were seated showed little crush intrusion. In fact, the crush damage observed on the wreckage showed that only the space where the pilot was seated was subjected to nonsurvivable crush intrusion. The airplane's nose,<sup>27</sup> cockpit, and cabin were crushed aft to an area immediately forward of the second window in the cabin passenger compartment. (See figure 4.)

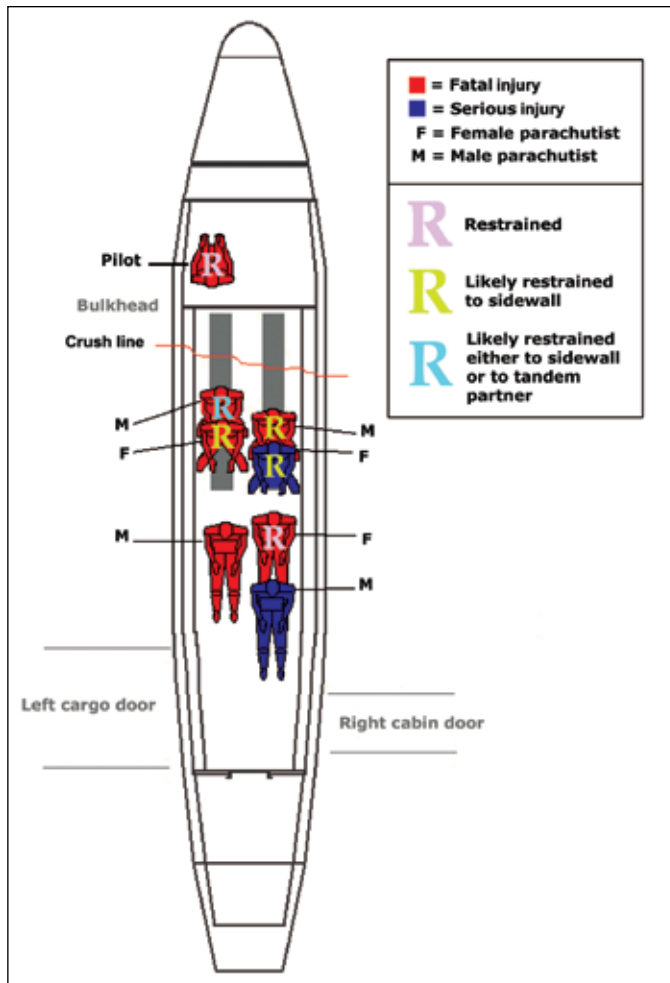
**Figure 5.** Seating diagram showing the approximate pre-accident locations of the parachutists and the pilot with respect to the crush-intrusion line.
