Collision with Terrain During Takeoff
of Parachute Jump Flight
Beech King Air 65-A90, N256TA
Mokuleia, Hawaii
June 21, 2019

NTSB/AAR-21/02
PB2021-100909

Aircraft Accident Report

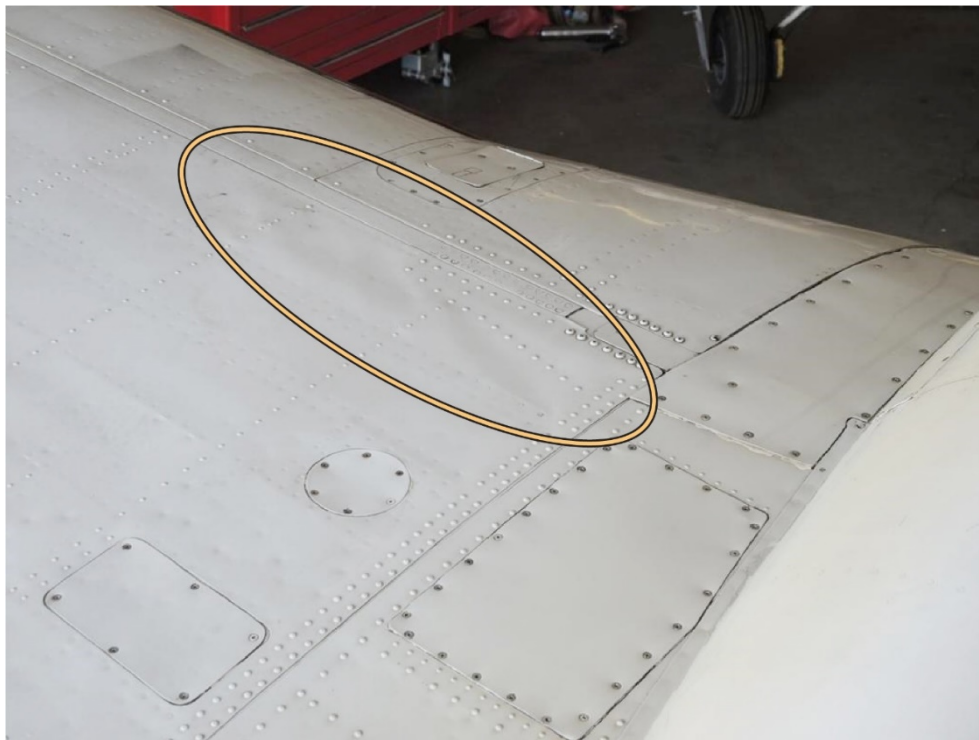
Photographs taken during the investigation of the July 2016 accident showed wrinkles in the top skin of the left wing immediately outboard of the engine and aft of the forward spar. The wrinkles, shown in figure 2, were consistent with compression buckling. The direction of wing twist indicated by the wrinkles was leading edge up for the wing tip.

Figure 2. Wrinkles in the top skin of the left wing after the July 2016 accident

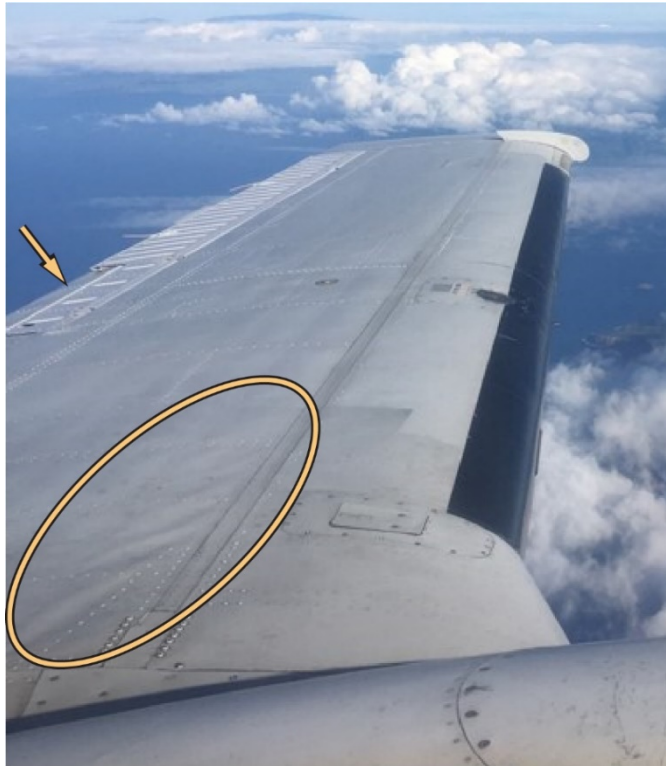
A video of the airplane from 2011 showed the trim tab on the left aileron close to the trailing, or normal, position, but the photographs taken during the 2016 accident investigation showed that the left aileron trim tab was deflected downward.³⁴ An in-flight photograph from the ferry flight to deliver the airplane from the US mainland to Hawaii in June 2017 also showed the deflection of the left aileron trim tab and wrinkled skin on the left upper wing, as shown in figure 3.³⁵

Note: The arrow indicates the aileron trim tab deflection, and the wrinkled skin is shown within the circle.

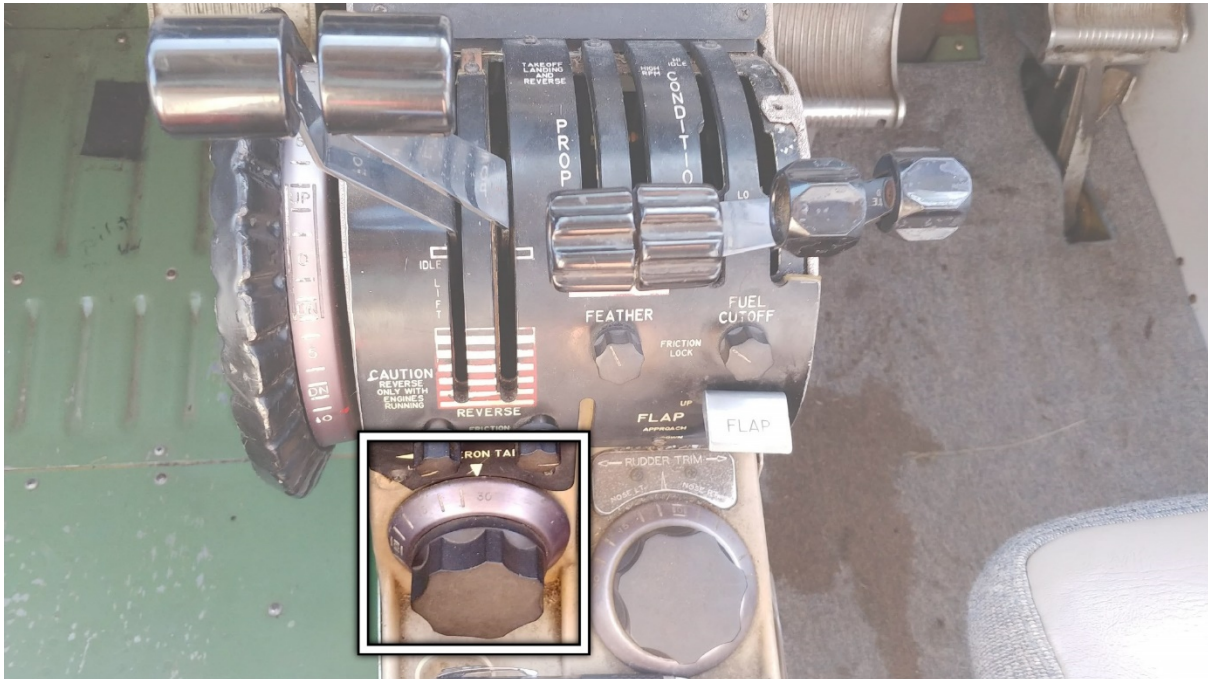
A photograph that was taken during the investigation of the 2016 accident showed that the aileron trim knob was set to the full left-wing-down position during the accident flight. A November 2018 photograph, which was taken about 1.5 years after completion of the repairs resulting from the 2016 accident, also showed the aileron trim knob set to the same position, as shown in figure 4.

Figure 4. Aileron trim knob in its full left-wing-down position

The aileron control stops in the left wing were found intact and unbent. The aft stop was found adjusted so that the bolt was almost fully seated. The bolt for the forward stop was fully extended and would have been contacted when the left aileron was moving in the trailing-edge-up direction. The aileron trim knob on the cockpit control pedestal was found in the full left-wing-down position.

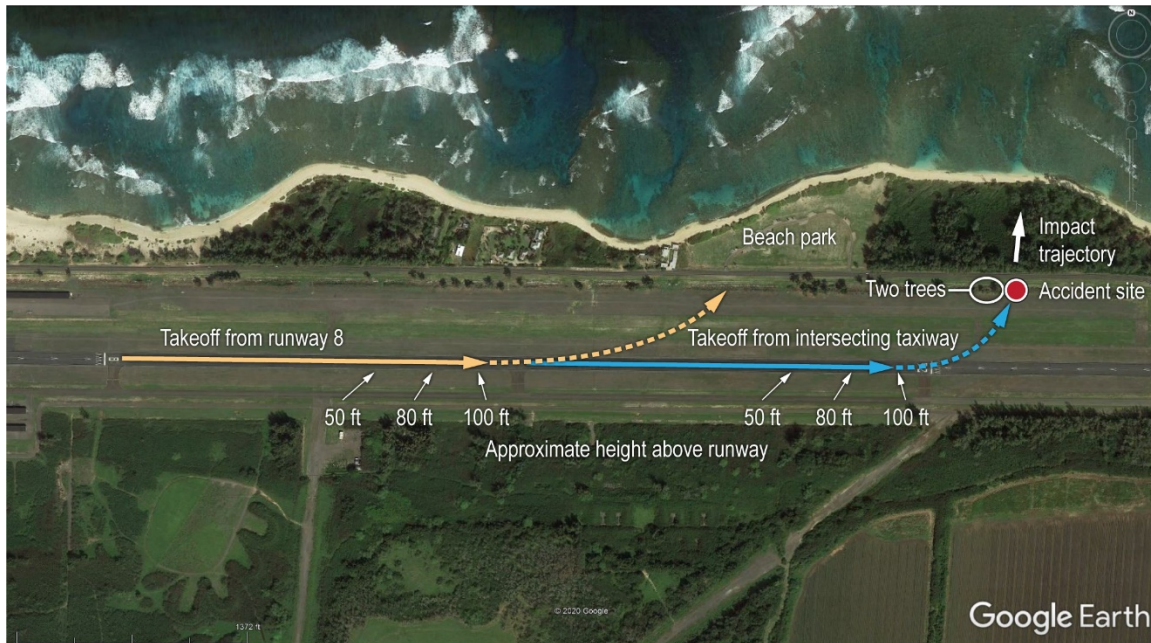
For the accident flight, there was no video or witness report indicating the airplane's location on the runway at the beginning of the takeoff roll. Because the accident location was directly under the flightpath (specifically, the location of the turn) of the previous flight, the NTSB determined that, for the accident flight, the pilot most likely followed a similar flight trajectory and performed a takeoff from the runway 8 intersection rather than the standard departure location, as shown in figure 7.

Note: The standard takeoff flight trajectory is shown in yellow, and the accident takeoff flight trajectory is shown in blue. The dotted blue line shows the calculated turn radius and not necessarily the accident flight's ground track. The location of the two trees, which were visible in the passenger video discussed in section 1.8.1, and the location of the accident site were used to determine the airplane's likely flight trajectory.

Figure 7. Comparison of the standard and accident takeoff flight trajectories
