JVS Building Services, LLC

Renovation

| | Billed to: | | | | | | |
|---|---|---|---|---|---|---|--|
| | | | nor | ie | Ridgely Airpark Renovation | net 30 | |

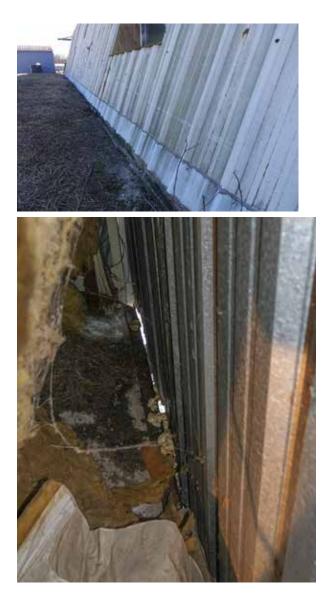
Because of the profile of the corrugated metal the siding provides access to the outside for air and rodents every sixteen inches.

The bottom image is of the space between the siding and the North wall in the main room. Aerosol foam was installed to close some of the openings but it's been ineffective. A nest can be seen in the space. A simple and relatively cheap solution to this would be to place crushed stone or gravel to a depth of fourteen inches along the wall and about two feet out around the perimeter of the building on both long walls and on the West wall. That would require about fourteen tons. Washed, 3/4" gravel from Pioneer Materials in Delaware costs \$33.90 per ton and they'll haul 23 tons to Ridgely for \$199. We should get twenty tons to make sure there's enough so the cost would be \$199 to haul it and \$678 for the material for a total of \$877. In addition to completely blocking 248 openings the gravel will prevent the rainwater that flows off the roof and down the walls from washing out the ground at the building perimeter.
