Collision with Terrain During Takeoff
of Parachute Jump Flight
Beech King Air 65-A90, N256TA
Mokuleia, Hawaii
June 21, 2019

NTSB/AAR-21/02
PB2021-100909

Aircraft Accident Report

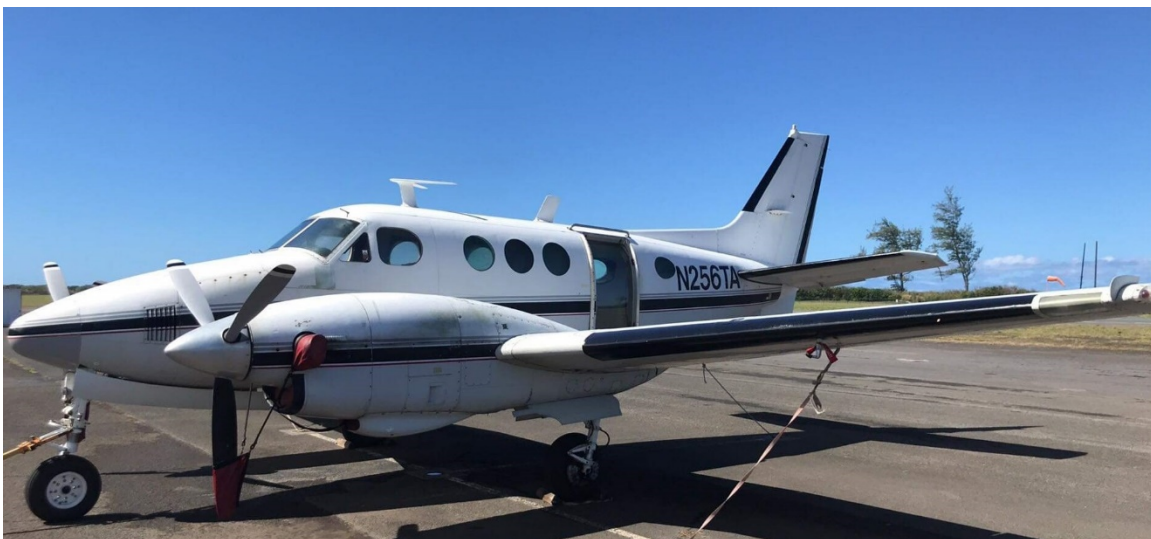
Figure 1. Accident airplane

Beechcraft Aircraft Corporation manufactured the accident airplane with the serial number LJ-256, and the FAA issued a standard airworthiness certificate for the airplane on March 2, 1967.²¹ The airplane had been owned by N80896 LLC, Granite Bay, California, since 2011 and was leased to OPC for 2 years starting May 15, 2017.²² Figure 1 shows the accident airplane at HDH.

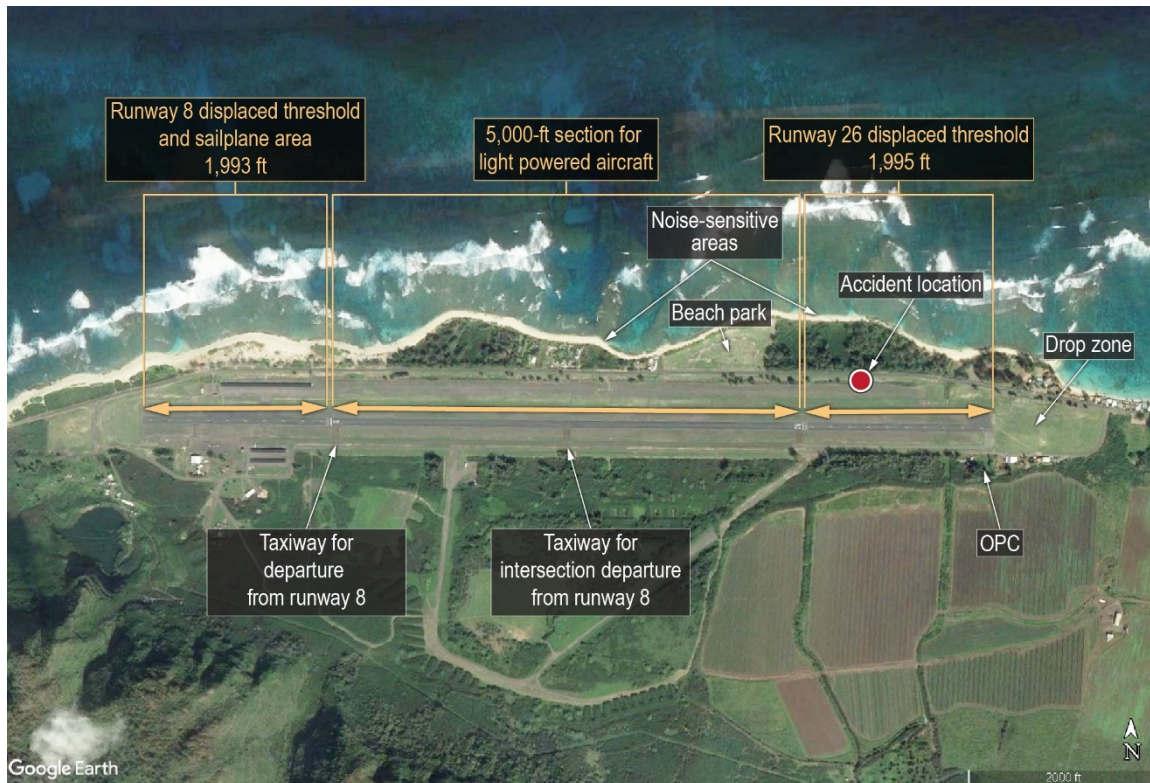
Figure 5. Airport environment

active parachute drop zone was located at the east end of the airport beyond the runway 26 displaced threshold. Figure 5 provides an overview of the airport.

According to the OPC owner and a former OPC pilot, for departures from runway 8, the airplane would turn left at midfield and fly over the adjacent beach park to avoid noise-sensitive areas along the beach and the drop zone at the east end of the airport. The accident airplane owner stated that he had observed takeoffs from runway 8 and did not see any operators (including OPC) perform intersection departures (that is, departures from any runway intersection other than the one at the runway designator). An intersection departure from the 5,000-ft section of runway 8 for light powered aircraft would leave about 2,500 ft of runway remaining. The 1,995-ft length of the runway 26 displaced threshold would also be available for departure.

According to a former OPC pilot, the standard departure from runway 8 necessitated a turn to the left at midfield to fly over the adjacent beach park to avoid the noise-sensitive areas along the beach and the drop zone at the east end of the runway (see figure 5). Airplane performance data were consistent with the former OPC pilot's statement and showed that, for a runway 8 departure using the 7,000 ft of runway available, the airplane had ample distance to rotate, climb, and turn toward the beach park (the established turning point) to avoid the noise-sensitive areas and the drop zone.⁶⁶ However, a departure from runway 8 using the intersecting taxiway at midfield would leave 4,500 ft of available runway for takeoff, resulting in rotation farther down the runway (adjacent to the beach park) and a turn soon thereafter to avoid the noise-sensitive areas and the drop zone.

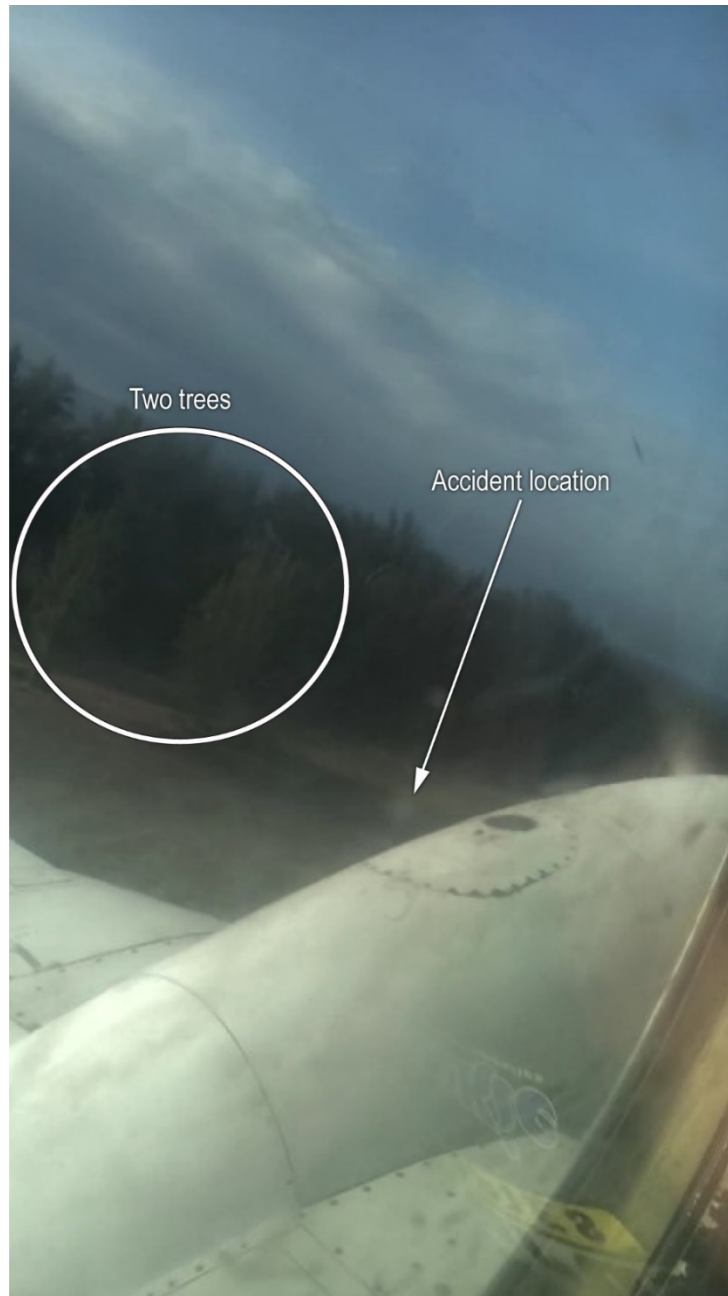
The NTSB received a video from a personal electronic device that was recorded by a passenger on the flight preceding the accident flight. The passenger video showed mostly the interior of the airplane; ground references—the ocean and two trees—were visible through a window for 3.5 seconds. The trees were visible for 2.1 seconds; during that timeframe, the airplane appeared to be in a nose-up attitude (having already departed from runway 8) and was transitioning to a left turn toward the ocean. Figure 6 is a still image from the video in which the two trees can be seen through one of the airplane windows; the location of the accident site is also noted.

The passenger video also recorded sound. The spectrum analysis of the sound signal indicated that both of the airplane's engines were operating at the same constant speed during the previous flight.

Figure 6. Video image from the flight preceding the accident flight showing the two trees in relation to the accident location
